JCAB CRA Problem Report Activity Since IPACG/23

IPACG/24 FIT/11
Honolulu, USA
25-27 January, 2006

JCAB CRA Activity Since FIT/10

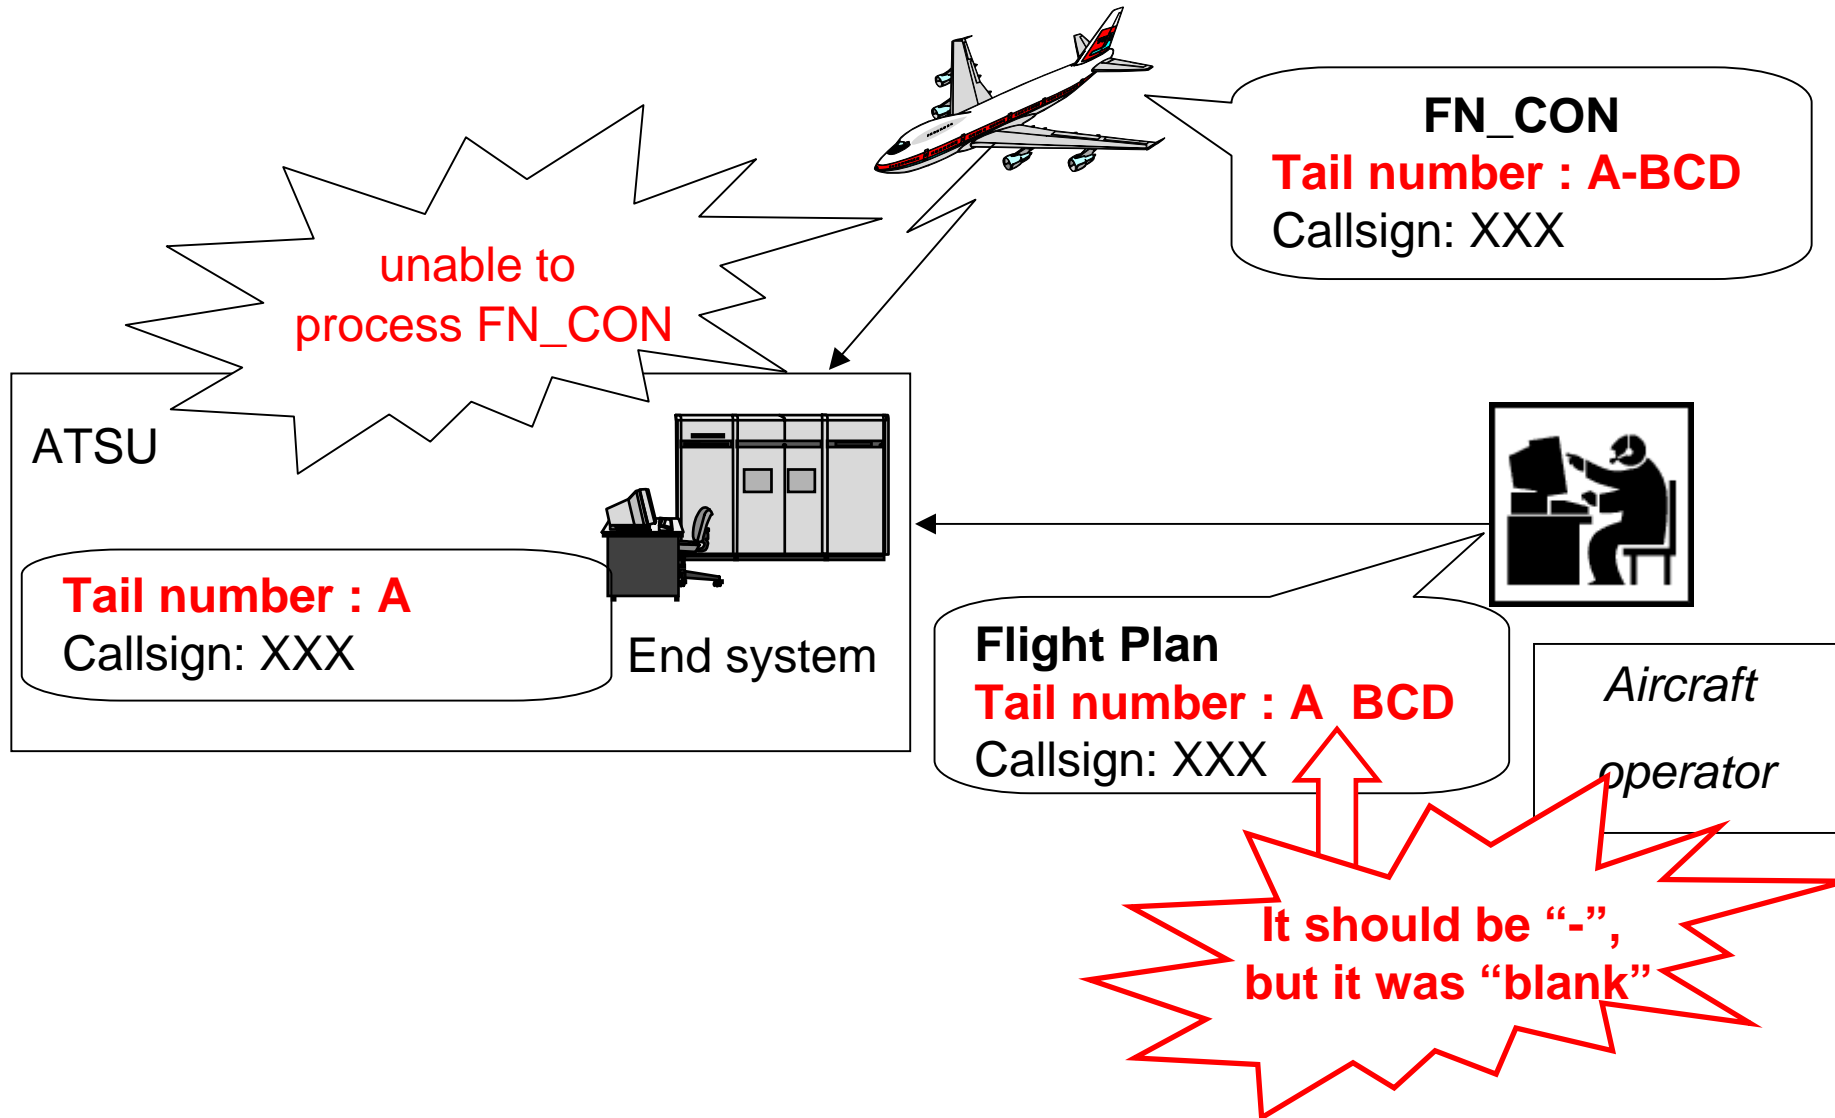
PR10376

- An aircraft was unable to logon.
- Flight Plan of the aircraft had its Tail Number with a space inserted in it, which was recognized as a delimiter for the data, so that the ATSU system considered only the data appeared before the space to be the Tail Number.
- Information of the event will be notified to the airline concerned to prevent similar event from occurring.

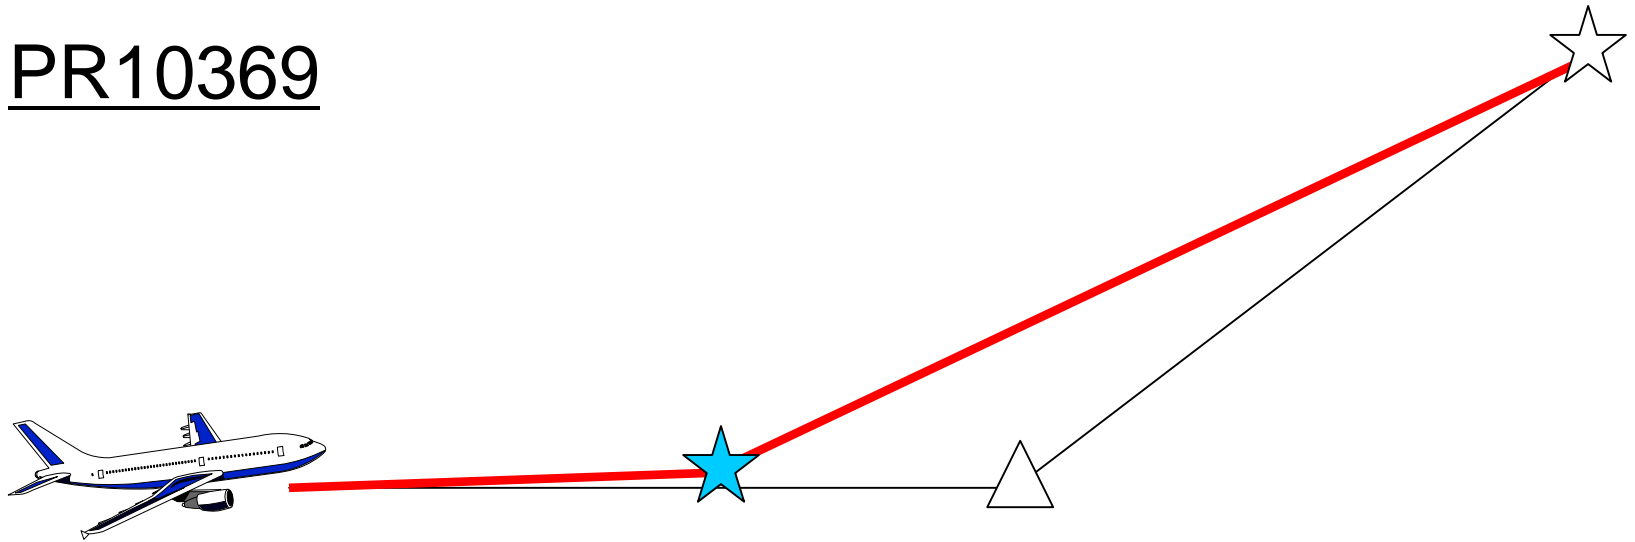
PR10369

- Observed on the ATC screen, was an aircraft that was flying on a different route from its flight planned route. In response to the controller's inquiry, the crew answered that its route was in line with the flight planned route.
- The crew seemed to input the point of latitude indicated in a CONTACT message just received and because the input point happened to be located on a point before an originally expected Next Waypoint, it was treated as a new Pred. Route (Next).
- Utilizing the Pred. Route (Next) and Fixed Intent data of an ADS Report, the ATSU End system displayed aircraft scheduled flight route.

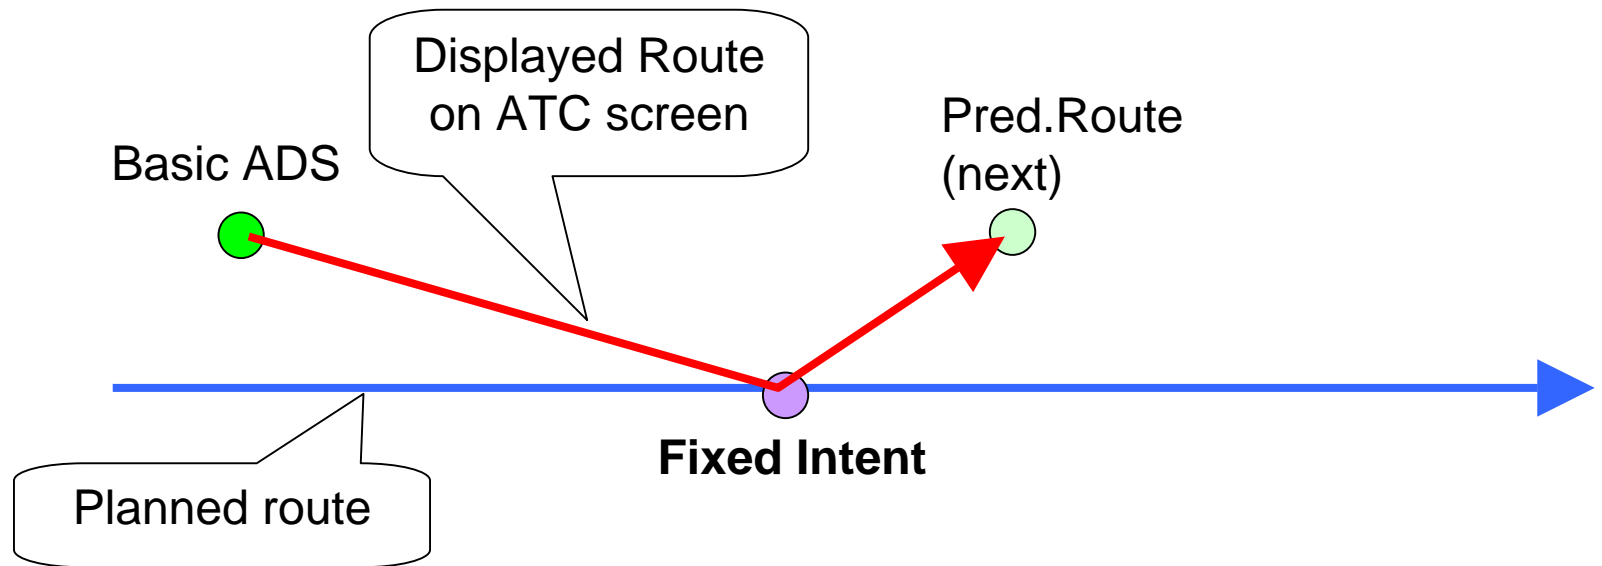
PR10377

- When monitoring a deviation flight, with its flight path was being displayed on the ATC screen, the controller found the displayed path was not on the flight planned route.
- The Pred. Route (Next) included in the Waypoint Event Report seems to have been created by the crew input of a Waypoint. The Fixed Intent of the Report indicated a point on the flight planned route.
- To be studied whether there is any way the crew could have flown the aircraft in a way that produces this kind of ADS Report.
